# Westlake Independent, Inc.

## WIHA Main Inspection

<b>Customer:</b>		<b>License:</b>	-
<b>Vehicle:</b>	2008 HONDA CR-V	<b>VIN:</b>	
<b>Inspection date:</b>	11/01/2016	<b>Odometer:</b>	109,526 miles
<b>Repair Order:</b>	62802	<b>Technician:</b>	Jose Delgado

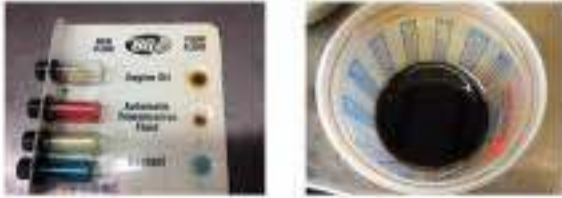
Transmission Fluid	<p>Dark  <i>Notes:</i>            See Fluid Tray Photo  <i>Image(s):</i></p>

<p><i>Click on image for original size</i></p>	Flush Transmission
Check Power Steering	<p>Dark  <i>Notes:</i>            See Fluid Tray Photo  <i>Image(s):</i></p>

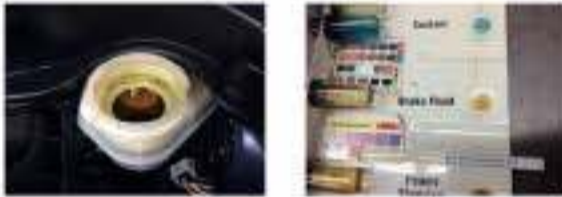
<p><i>Click on image for original size</i></p>	Flush System
Brake Fluid	<p>Low            Dark  <i>Notes:</i>            See Fluid Tray Photo  <i>Image(s):</i></p>

<p><i>Click on image for original size</i></p>	Flush Brake System
Drive Belts	<p>WORN  <i>Image(s):</i></p>

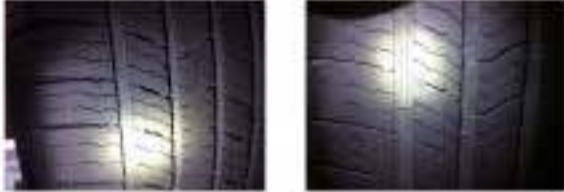
<i>Click on image for original size</i>	Replace
<b>Under Car</b>	<b>Observation</b>	<b>Action</b>
Right Front Tire	Cracking Rubber 3/32 Tread Left <i>Image(s):</i>

<i>Click on image for original size</i>	Replace Tires Alignment

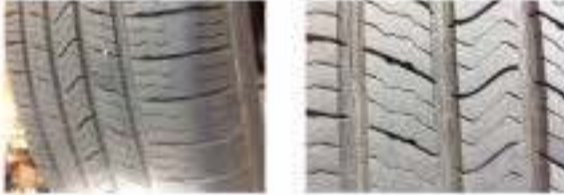
<p><i>Click on image for original size</i></p>	Replace Tire Alignment
Left Rear Tire	<p>Cracking Rubber Worn on Edges 2/32 Tread Left <i>Image(s):</i></p>

<p><i>Click on image for original size</i></p>	Replace Tire Alignment
Front Strut/Shocks	<p>Other <i>Notes:</i> Front struts are soft + missing the dust boots <i>Image(s):</i></p>

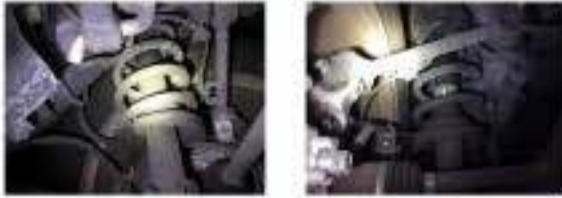
<b>Rear Strut/Shock</b>	<p>Leaking Level 5  <i>Notes:</i>            Rear struts leaking  <i>Image(s):</i></p>

<p><i>Click on image for original size</i></p>	Replace
<b>Rear Differential Fluid</b>	<p>Fluid Dirty  <i>Image(s):</i></p>
