WIHA Main Inspection

Customer:		License:	-
Vehicle:	2008 HONDA CR-V	VIN:	
Inspection date:	11/01/2016	Odometer:	109,526 miles
Repair Order:	62802	Technician:	Jose Delgado

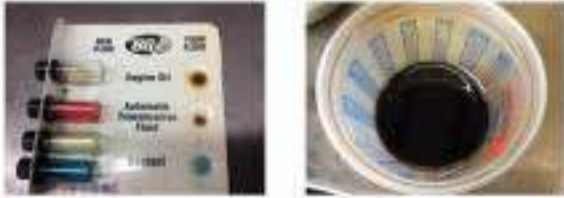
Transmission Fluid	<p>Dark <i>Notes:</i> See Fluid Tray Photo <i>Image(s):</i></p>

<p><i>Click on image for original size</i></p>	Flush Transmission
Check Power Steering	<p>Dark <i>Notes:</i> See Fluid Tray Photo <i>Image(s):</i></p>

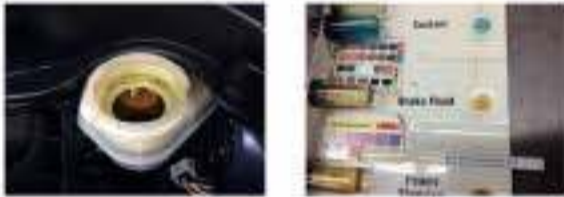
<p><i>Click on image for original size</i></p>	Flush System
Brake Fluid	<p>Low Dark <i>Notes:</i> See Fluid Tray Photo <i>Image(s):</i></p>

<p><i>Click on image for original size</i></p>	Flush Brake System
Drive Belts	<p>WORN <i>Image(s):</i></p>

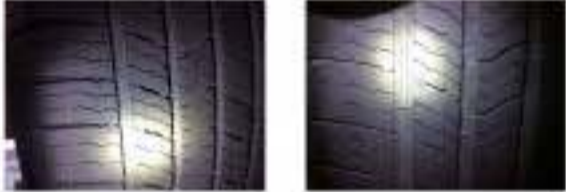
<i>Click on image for original size</i>	Replace
Under Car	Observation	Action
Right Front Tire	Cracking Rubber 3/32 Tread Left <i>Image(s):</i>

<i>Click on image for original size</i>	Replace Tires Alignment

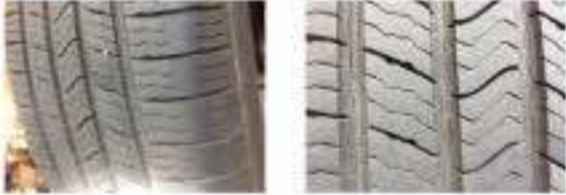
<p><i>Click on image for original size</i></p>	<p>Replace Tire Alignment</p>
Left Rear Tire	<p>Cracking Rubber Worn on Edges 2/32 Tread Left <i>Image(s):</i></p>

<p><i>Click on image for original size</i></p>	<p>Replace Tire Alignment</p>
Front Strut/Shocks	<p>Other <i>Notes:</i> Front struts are soft + missing the dust boots <i>Image(s):</i></p>
